6/17/2024 | 27 Photos

1531 North 18th Street Roof Report

A comprehensive roof report that includes photos and analysis.

An inspection was performed on June 13th, 2024. Sections 1 and 2 appear to be in great shape while section 3 and 4 may be nearing the end of their expected service life.

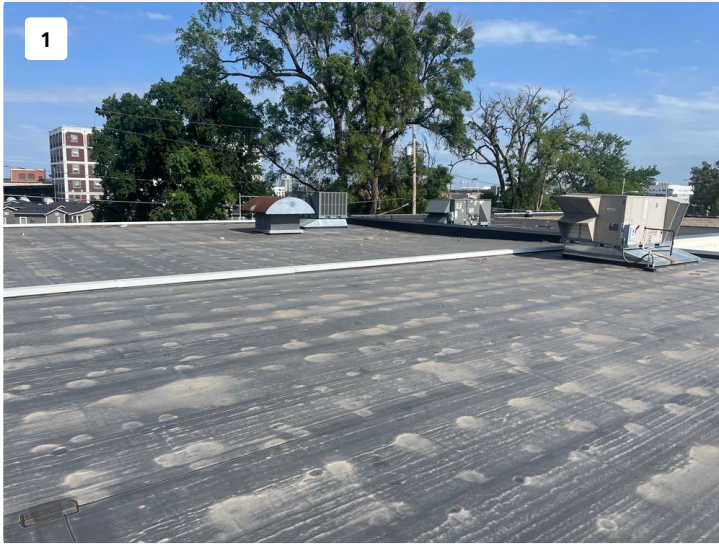
Field seams are in great shape.

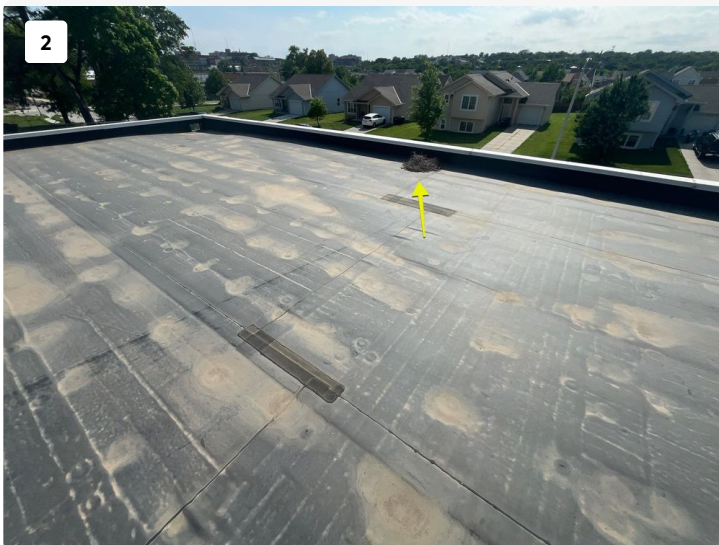
Minor detail patching has been performed.

Small amount of debris on roof.

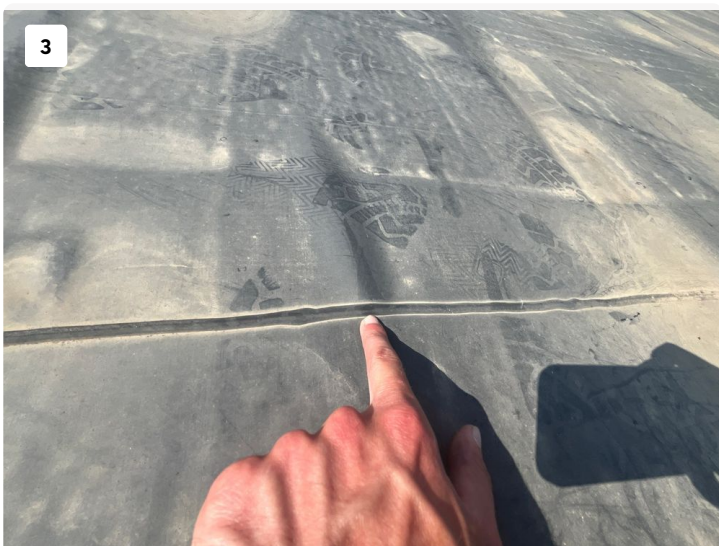
All seams have been addressed with an adhesive. Adhesive is holding up well and saw no gaps or cracks.

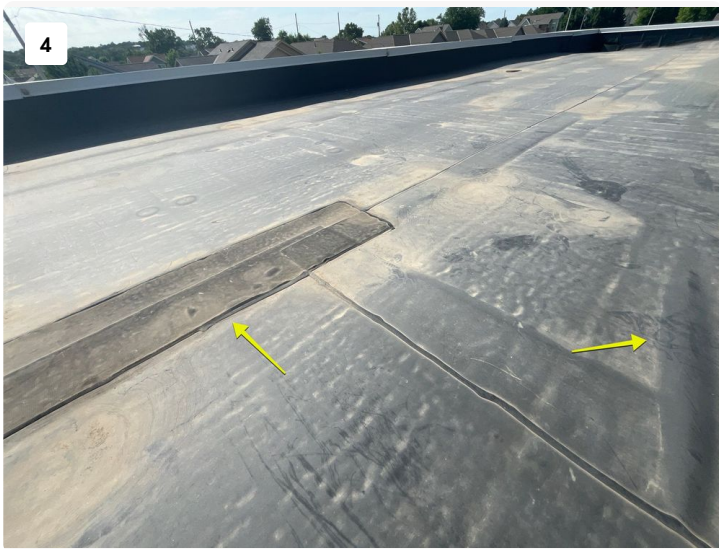
Slight wrinkle in the membrane.

EPDM patch is holding up well. Seams were addressed around it.

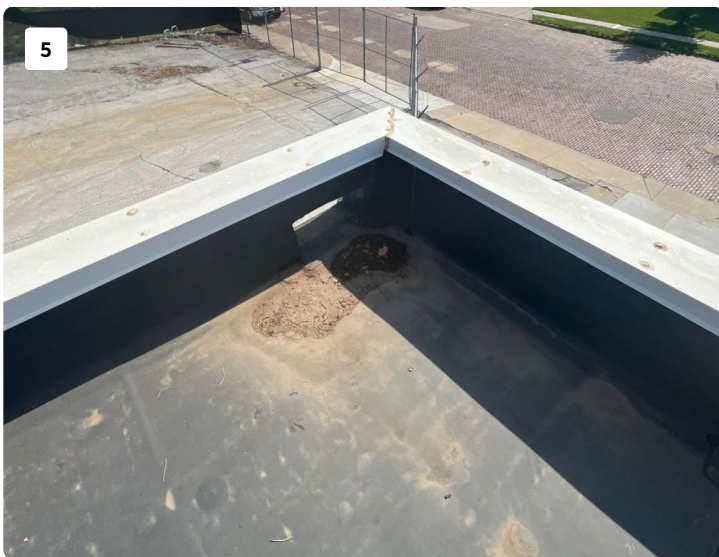
Roof 1 has two scuppers that the roof slopes toward on the northwest and southwest side. Minor ponding water area near scupper.

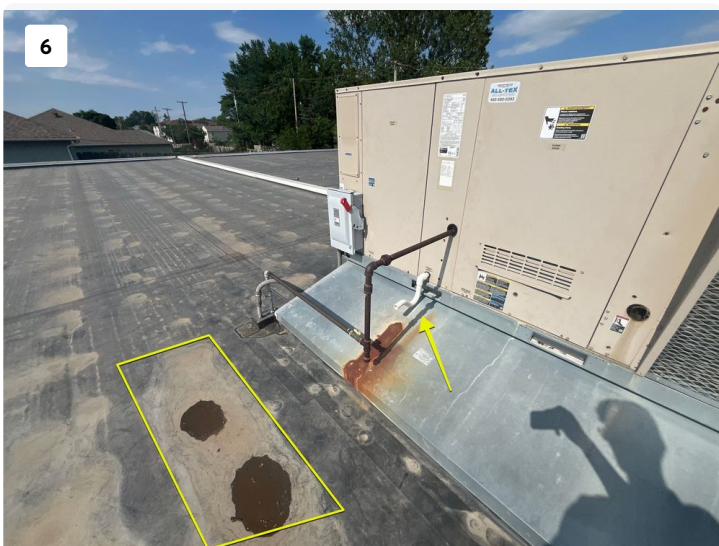
Condensation line not ran to gutter. Causing the metal curb to rust out.

Minor ponding water area near the front of the RTU.

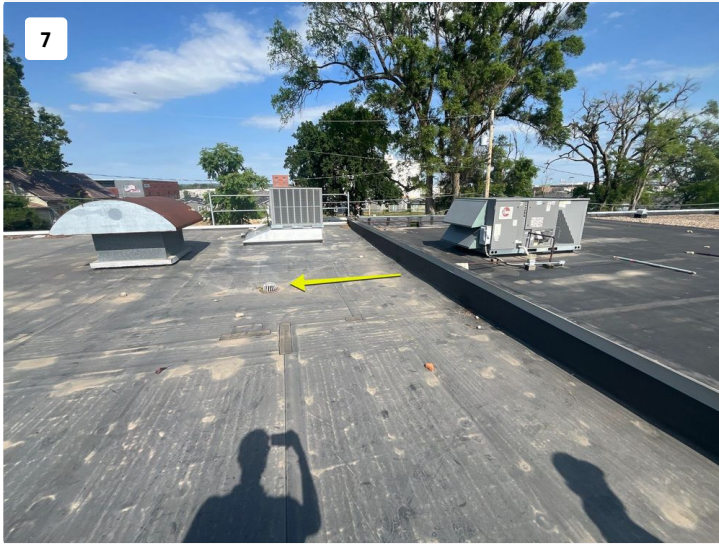
Roof section 2 has one internal drain. The entire roof slopes towards this drain.

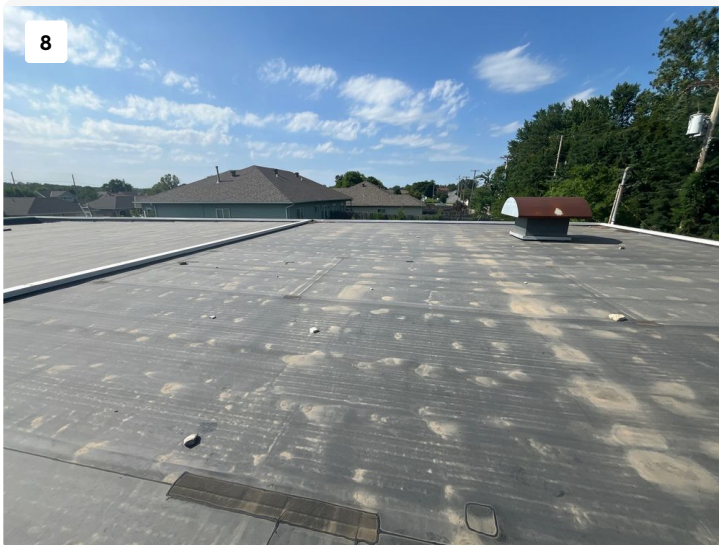
Roof section 2 has great drainage and the seams have all been addressed with an adhesive. No cracks or gaps on the seams.

This section has minor debris that could puncture the EPDM membrane. This should be removed.

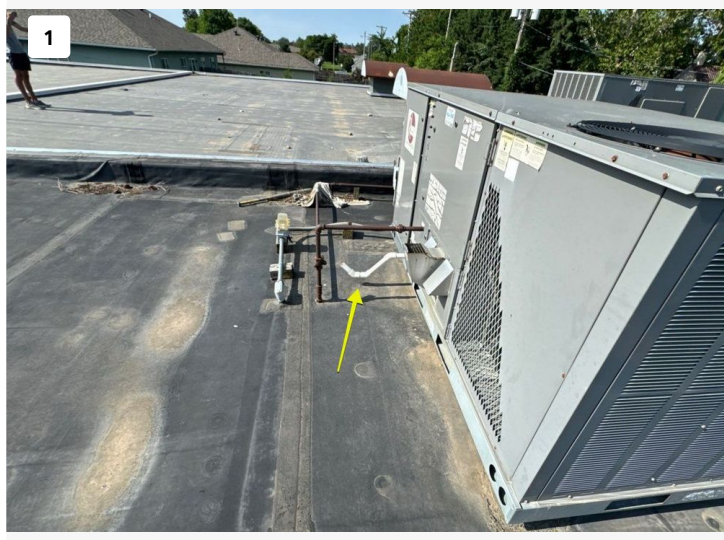
Condensation line not ran to gutter.

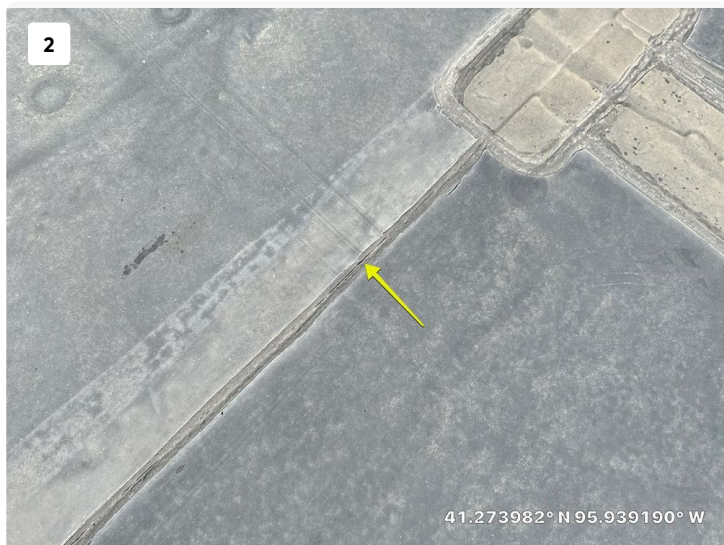
Splitting of field seam.

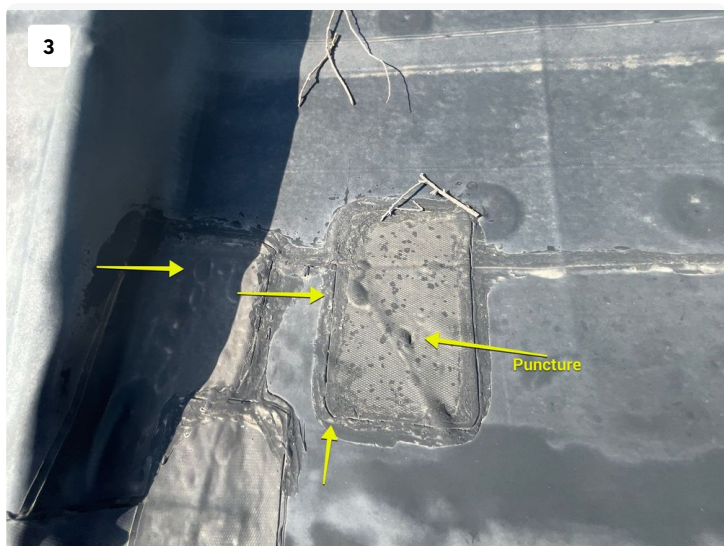
Air bubble underneath EPDM patch.
Puncture in the membrane.
Detail patch seams are starting to fail.

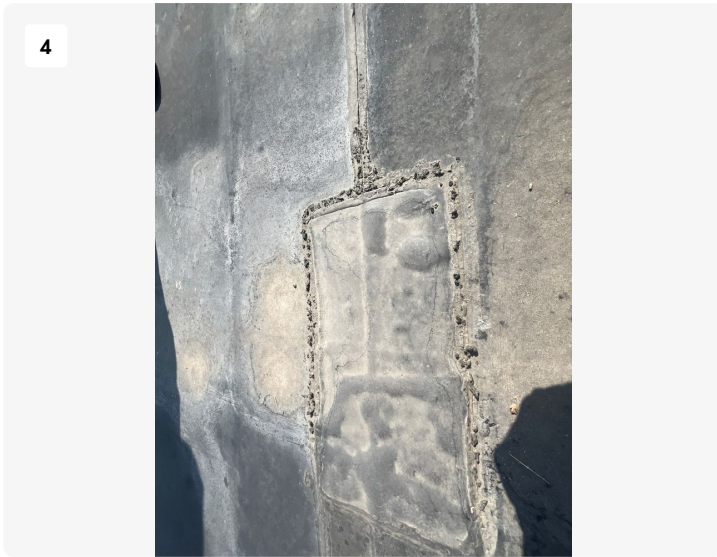
Deteriorated seams around EPDM patch. There are also small bubbles forming underneath EPDM.

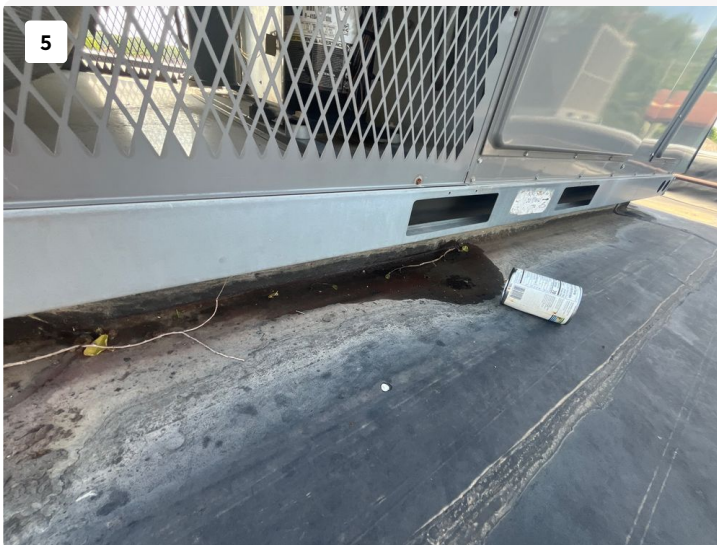
Loose debris.

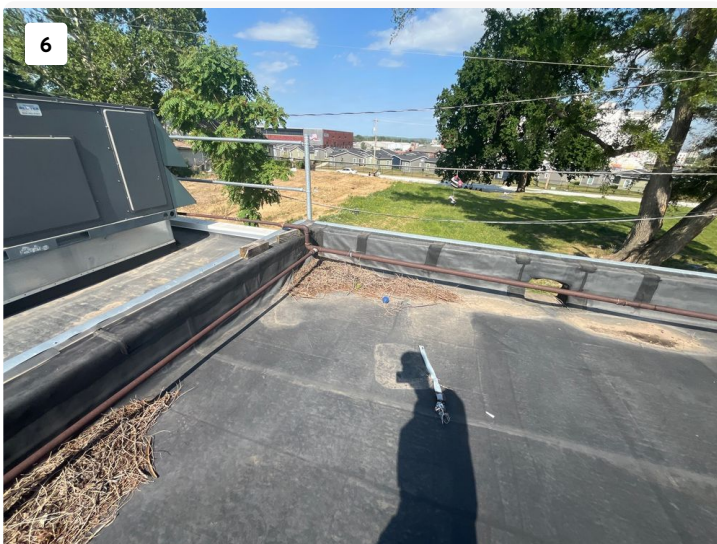
Debris on the roof near the scupper. This should be removed.

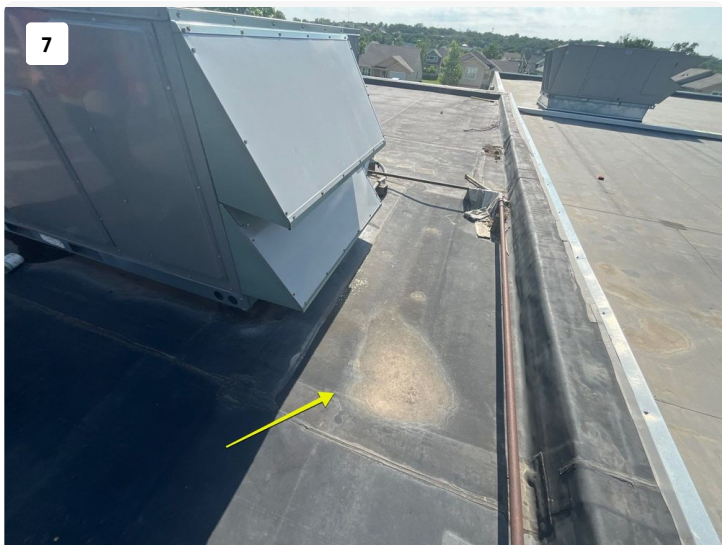
Minor ponding water near an RTU.

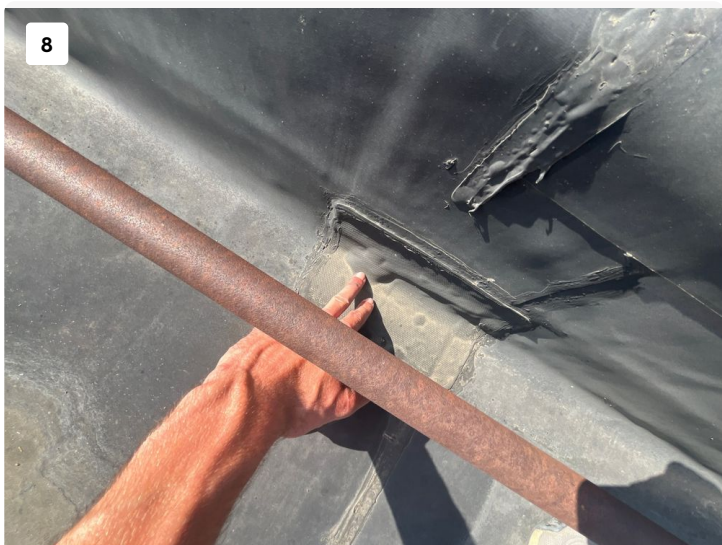
Air bubble underneath EPDM patch.

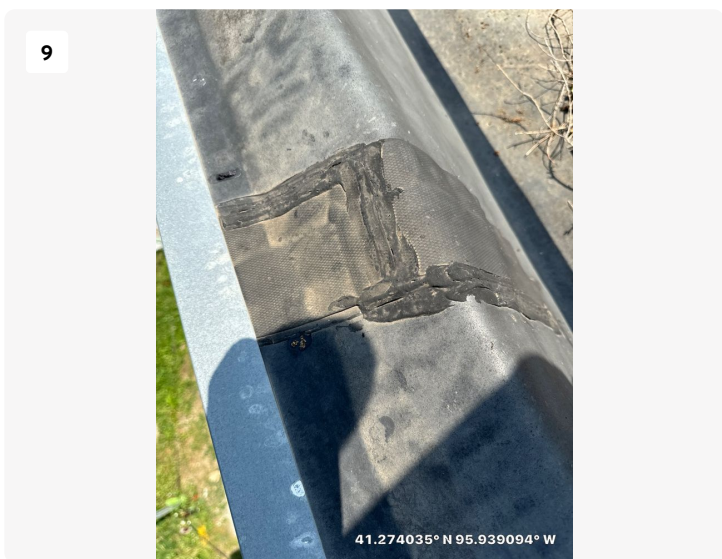
Failing adhesive around EPDM patch.

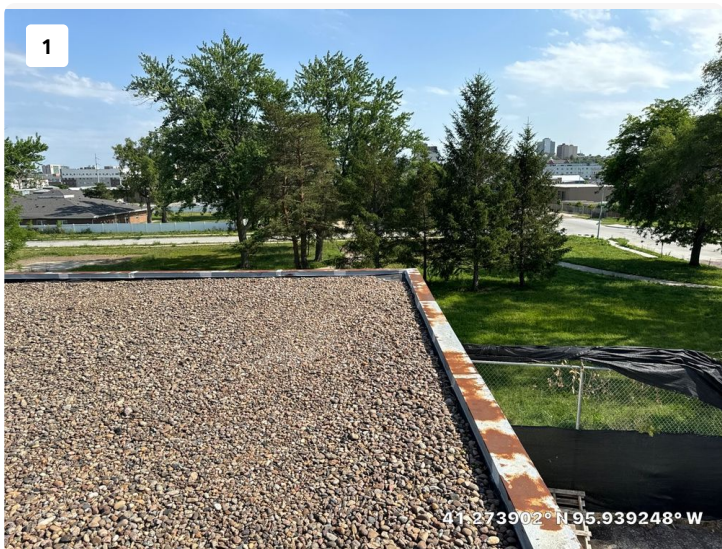
Rusted metal flashing around entire perimeter.

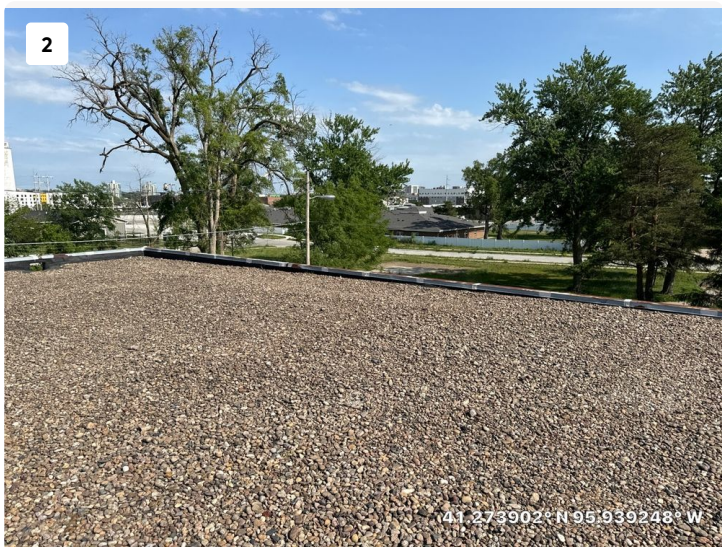
Rock coverage is great. No gaps in coverage.

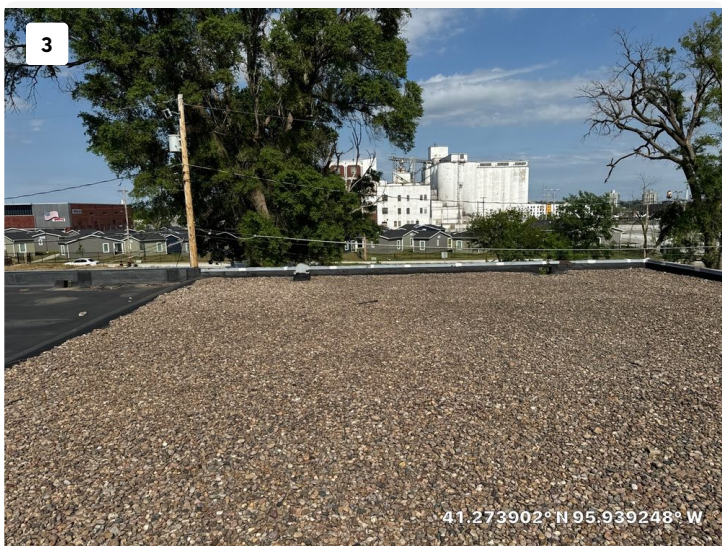
Rooftop vent has minor patch failure.

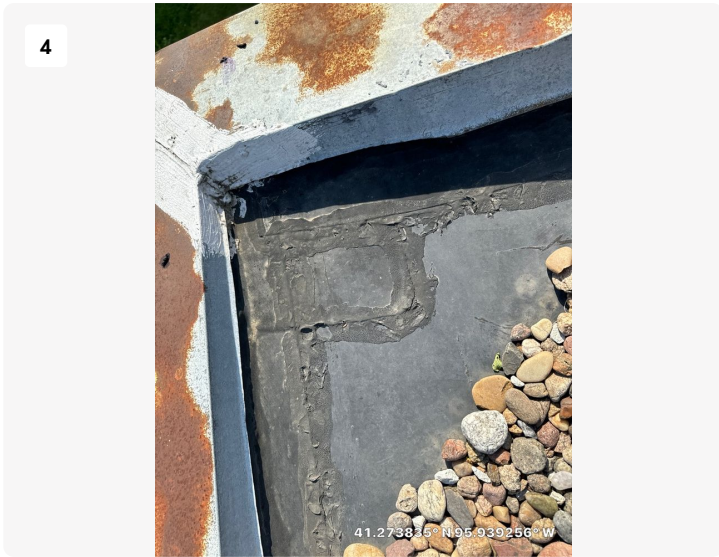
Membrane tenting in the corner. Adhesive is holding up fine but could begin to fail soon.

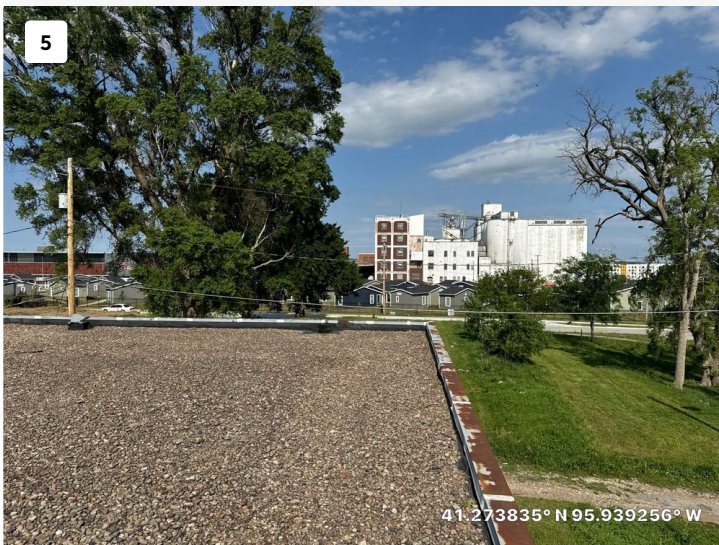
Roof slopes to the East wall well. Water does not pond on this roof.

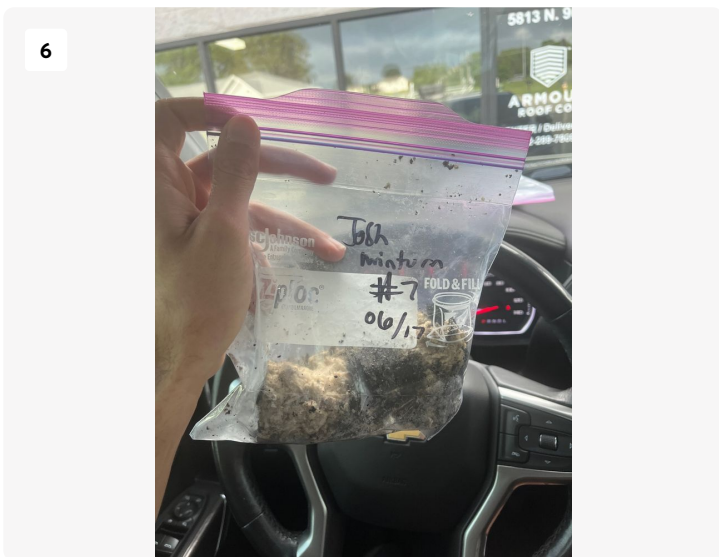
Saturated Insulation.

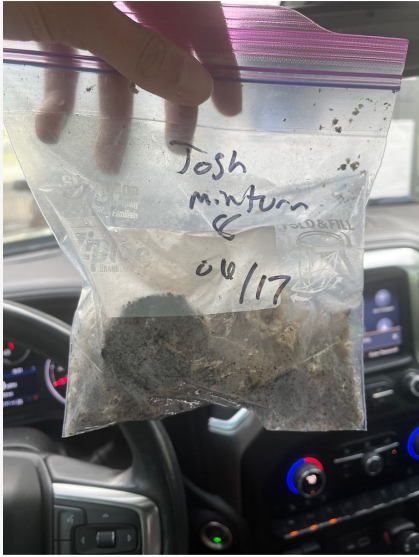
Saturated Insulation.
